**Flood Control Project Maintenance
Levee Inspections**

Fall 2015 Levee Maintenance Deficiency Summary Report

Sacramento River Basin

Marysville Levee Commission

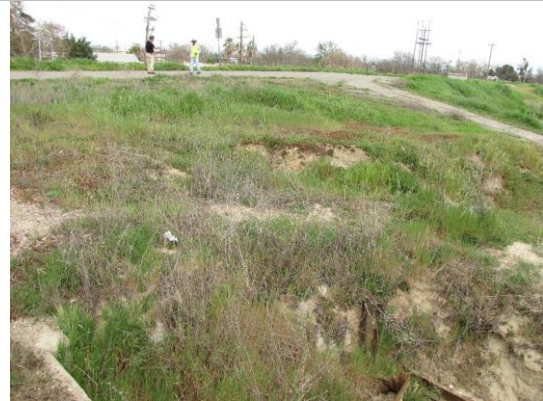
Photo 1 of 3 : UCIP_FA_2015_6392.jpg

LM Start	0.48	Rating **	U	Issue No.	43
LM End	0.48	Issue Type +	En	Location *	LS
Category	Supplemental			GPS Latitude/Longitude	
				Start	End
Item	DWR UCIP Field Study			39.135976 °	39.135976 °
				-121.585434 °	-121.585434 °
DWR ID					
Action/Comments					
Inspector Comments: FS_ID:42048					
DS_ID:19134					
EP_NO: N/A					
FS_HLM: 0.496					
Repair Type: Urgent					
Crossing Status: Indicator Found

View of waterward side.

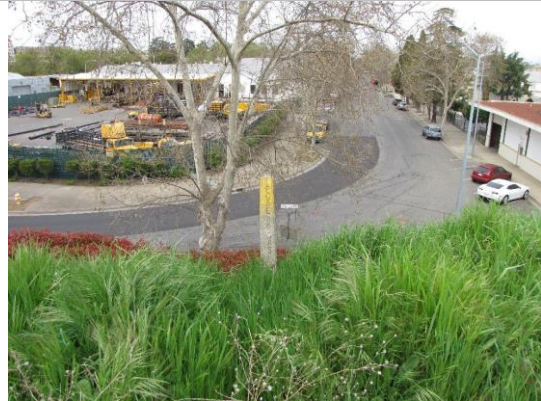
Photo 3 of 3 : UCIP_FA_2015_6394.jpg

LM Start	0.48	Rating **	U	Issue No.	43 (cont)
LM End	0.48	Issue Type +	En	Location *	LS
Category	Supplemental			GPS Latitude/Longitude	
				Start	End
Item	DWR UCIP Field Study			39.135976 °	39.135976 °
				-121.585434 °	-121.585434 °
DWR ID					
Action/Comments					
Inspector Comments: FS_ID:42048					
DS_ID:19134					
EP_NO: N/A					
FS_HLM: 0.496					
Repair Type: Urgent					
Crossing Status: Indicator Found

View of landward side.

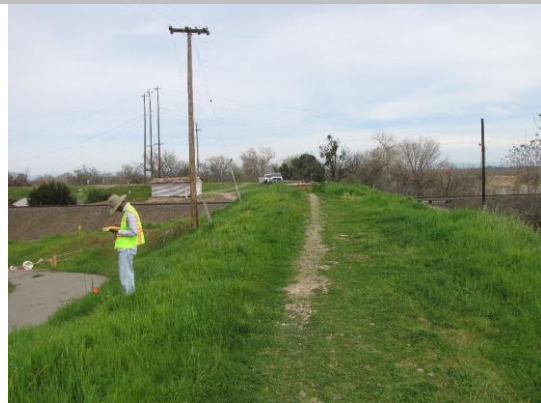
Photo 1 of 2 : UCIP_FA_2015_5993.jpg

LM Start	0.55	Rating **	U	Issue No.	44
LM End	0.55	Issue Type +	En	Location *	LS
Category	Supplemental			GPS Latitude/Longitude	
				Start	End
Item	DWR UCIP Field Study			39.136348 °	39.136348 °
				-121.584171 °	-121.584171 °
DWR ID					
Action/Comments					
Inspector Comments: FS_ID:42049 DS_ID:25058 EP_NO: N/A FS_HLM: 0.572 Repair Type: Urgent Crossing Status: Indicator Found UCIP Comments: Unable to confirm if marker is for new line or if marker is for crossing immediately upstream of this marker.Frank Miller Superintendent Marysville Levee Commission.To whom it may concern, Marysville Levee Commission is in process of drafting a letter to determine line owner as well as line status, wether active or non-active as well as coordinates. FIELD_STRUCT_DESC: Underground service alert (USA) flags visible on landward side. Points recorded for this line include 39.1363869999, -121.584067444; 39.136348328, -121.584171185 FS Date: 03/14/2013

View of levee crown.

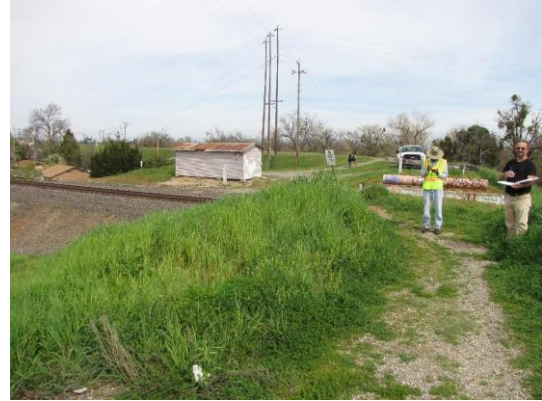
Photo 2 of 3 : UCIP_FA_2015_6396.jpg

UCIP Comments: Need to contact owner to determine status of crossing. Need date of last inspection and confirmation that crossing is still in operable condition. Multiple indicators of gas lines unable to confirm if this crossing is the line referenced in desk study--Need to contact owner. Frank Miller Superintendent Marysville Levee Commission. To whom it may concern, Marysville Levee Commission is in process of drafting a letter to South Pacific Pipe Lines Inc. to determine line status, whether active non-active, as well as coordinates. FIELD_STRUCT_DESC: 8-5/8-inch steel gas line sleeved through 12 inch, then 30 inch line, annular gaps grouted, 3 feet below crown. Standard metal cutoff wall around pipe in line with shoulder. Extends beyond levee on both waterward and landward sides. (Permit No. 3823-1962).

View of upstream levee.

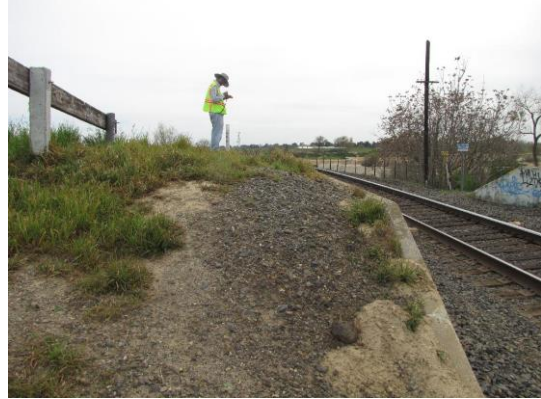
Photo 2 of 3 : UCIP_FA_2015_6399.jpg

Inspector Comments: FS_ID:40975
 DS_ID:25059
 EP_NO: N/A
 FS_HLM: 0.606
 Repair Type: Non-Urgent
 Crossing Status: Indicator Found
 UCIP Comments: Need to coordinate with owner to determine status of crossing, details of crossing (install date and pipe size) and CVFPB permit number issued.
 FIELD_STRUCT_DESC: Communication line marker found near levee crown.
 FS Date: 03/14/2013

View of landward side.

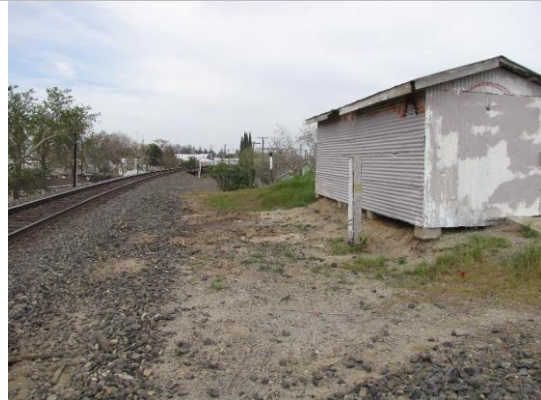
Photo 3 of 3 : UCIP_FA_2015_6400.jpg

View of landward side.

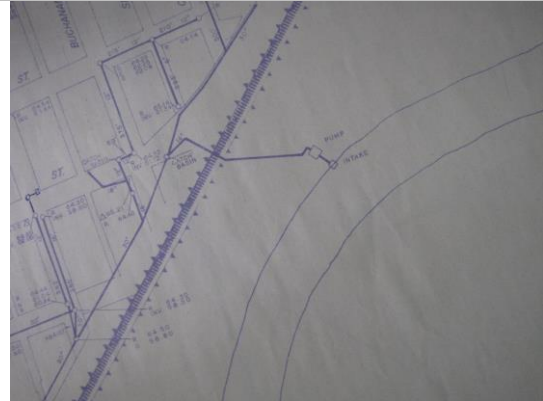
Photo 1 of 1 : UCIP_FA_2015_0306.jpg

LM Start	1.60	Rating **	M	Issue No.	50
LM End	1.60	Issue Type +	En	Location *	WS
Category	Supplemental			GPS Latitude/Longitude	
				Start	End
Item	DWR UCIP Field Study			39.149063 °	39.149063 °
				-121.577190 °	-121.577190 °
DWR ID					
Action/Comments					
Inspector Comments: FS_ID:45363 DS_ID:19142 EP_NO: 7066 FS_HLM: 1.65 Repair Type: Non-Urgent Crossing Status: Indicator Found UCIP Comments: Unable to take coordinates due to limited access to waterward side, used desk study coordinates. FIELD_STRUCT_DESC: 14-inch pipe through levee, 6 feet below levee crown. Discharges into Ellis Lake. Slant pump mounted on Metal Pump Stand located approximately 150 feet from waterward toe. (Permit No. 7066B, 7066A, 7066). FS Date: 03/14/2013

As-built dwg provided by Marysville Water Waste Treatment Plant.

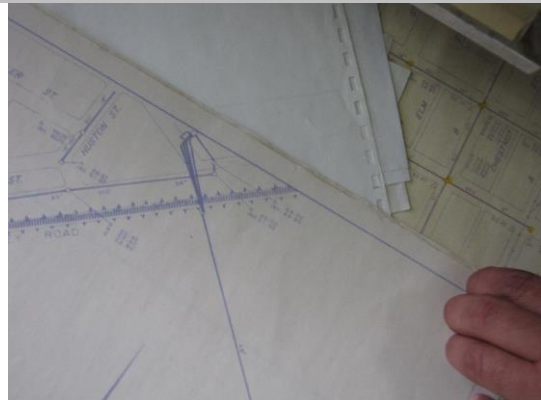
Photo 3 of 3 : UCIP_FA_2015_6503.jpg

LM Start	2.18	Rating **	M	Issue No.	52 (cont)	
LM End	2.18	Issue Type +	En	Location *	WS	
Category	Supplemental			GPS Latitude/Longitude		
				Start	End	
Item	DWR UCIP Field Study			39.154735 °	39.154735 °	
				-121.569419 °	-121.569419 °	
DWR ID						
Action/Comments						
Inspector Comments: FS_ID:40999						
DS_ID:19145						
EP_NO: 2149						
FS_HLM: 2.225						
Repair Type: Non-Urgent						
Crossing Status: Indicator Found						
UCIP Comments: Depression observed on waterward toe filled with concrete rubble and riprap. Need to coordinate with City to determine records and extent of modifications if any.						
FIELD_STRUCT_DESC: 1 of 4: 17th & Howell Pump Station. 24-inch steel drain pipe (instead of 30 inch as specified in permit), buried 15-feet below the crown. Runs parallel to other drainpipes, encased in concrete approx. 1-foot spacing. Pipe extends from storm water pump house to manhole (259 feet) north of landward toe. Flap gates and vent pipes at waterward toe. Discharges into concrete distribution box (3x4 foot). (Permit No. 2149-1956).

As-built provided by Marysville Water Treatment Facility.

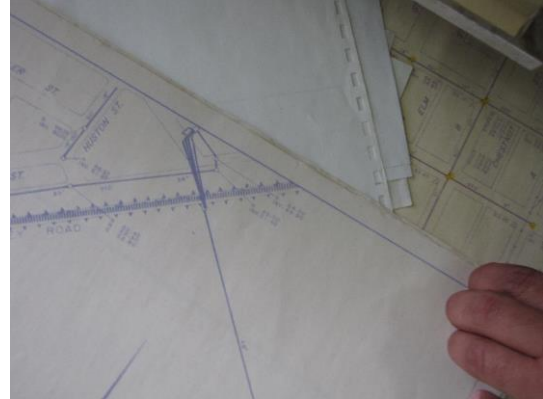
Photo 3 of 3 : UCIP_FA_2015_6578.jpg

LM Start	2.18	Rating **	M	Issue No.	53 (cont)
LM End	2.18	Issue Type +	En	Location *	WS
Category	Supplemental			GPS Latitude/Longitude	
				Start	End
Item	DWR UCIP Field Study			39.154741 °	39.154741 °
				-121.569413 °	-121.569413 °
DWR ID					
Action/Comments					
Inspector Comments: FS_ID:40998					
DS_ID:19160					
EP_NO: 2149					
FS_HLM: 2.226					
Repair Type: Non-Urgent					
Crossing Status: Indicator Found

As-builts provided by Marysville Water Treatment.

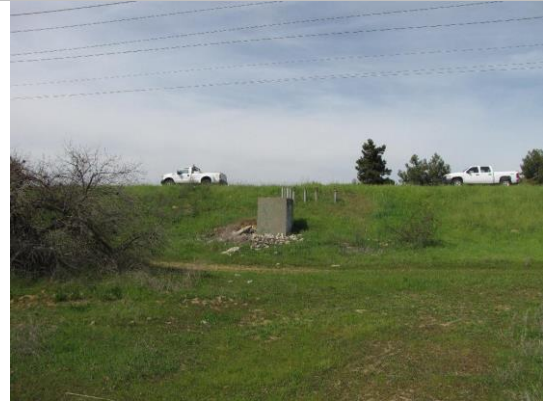
Photo 2 of 3 : UCIP_FA_2015_6580.jpg

LM Start	2.18	Rating **	M	Issue No.	54
LM End	2.18	Issue Type +	En	Location *	WS
Category	Supplemental			GPS Latitude/Longitude	
				Start	End
Item	DWR UCIP Field Study			39.154746 °	39.154746 °
				-121.569406 °	-121.569406 °
DWR ID					
Action/Comments					
Inspector Comments: FS_ID:41000 DS_ID:19162 EP_NO: 2149 FS_HLM: 2.227 Repair Type: Non-Urgent Crossing Status: Indicator Found UCIP Comments: Depression observed on waterward toe filled with concrete rubble and riprap. Need to coordinate with City to determine records and extent of modifications if any. FIELD_STRUCT_DESC: 3 of 4: 17th & Howell Pump Station. 24-inch steel drain pipe (instead of 30 inch as specified in permit), buried 15-feet below the crown. Runs parallel to other drainpipes, encased in concrete approx. 1-foot spacing. Pipe extends from storm water pump house to manhole (259 feet) north of landward toe. Flap gates and vent pipes at waterward toe. Discharges into concrete distribution box (3x4 foot). (Permit No. 2149-1956). FS Date: 03/14/2013

View of waterward side.

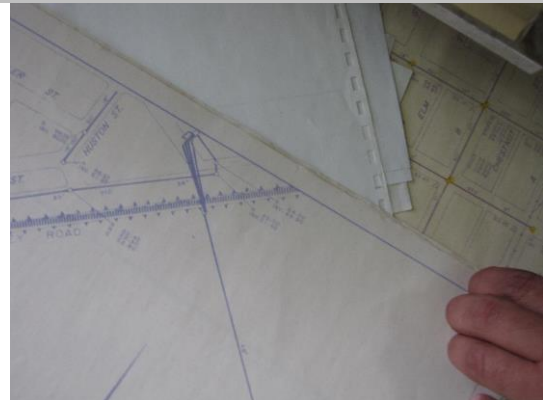
Photo 3 of 3 : UCIP_FA_2015_6581.jpg

As-built dwg of crossing provided by Marysville Water Treatment.

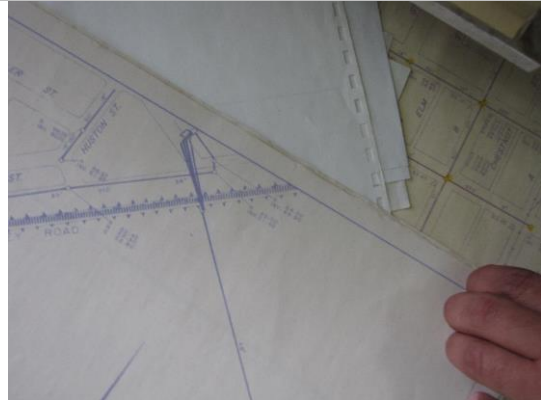
Photo 2 of 3 : UCIP_FA_2015_6499.jpg

City of Marysville Wastewater Treatment Facility records indicating multiple crossings through levee.

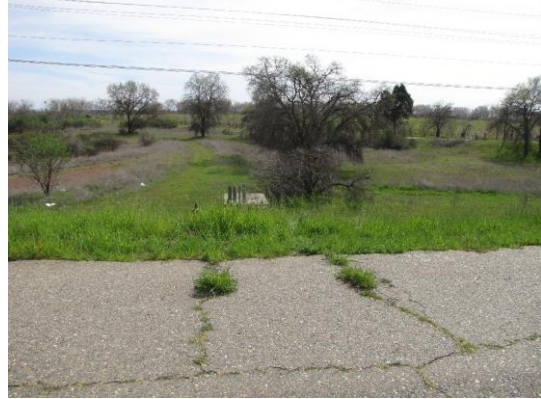
Photo 3 of 3 : UCIP_FA_2015_6500.jpg

LM Start	2.18	Rating **	M	Issue No.	55 (cont)
LM End	2.18	Issue Type +	En	Location *	WS
Category	Supplemental			GPS Latitude/Longitude	
				Start	End
Item	DWR UCIP Field Study			39.154752 °	39.154752
				-121.569395 °	-121.569395
DWR ID					
Action/Comments					
Inspector Comments: FS_ID:41001					
DS_ID:19161					
EP_NO: 2149					
FS_HLM: 2.228					
Repair Type: Non-Urgent					
Crossing Status: Indicator Found

View of waterward side.

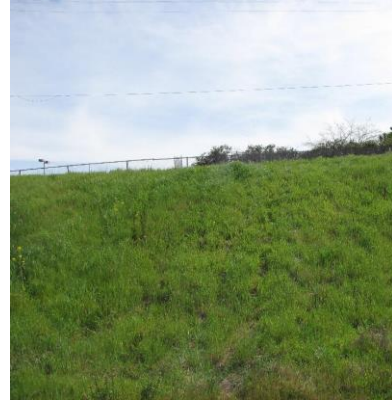
Photo 1 of 2 : UCIP_FA_2015_1287.jpg

LM Start	3.30	Rating **	M	Issue No.	56 (cont)
LM End	3.30	Issue Type +	En	Location *	LS

View of landward side.
